# **1982 CB ANNUAL REPORT**

**SUMMARY OF DEVELOPMENT ACTIVITIES,  
COSTS AND ENVIRONMENTAL MONITORING**

**CATHEDRAL BLUFFS SHALE OIL COMPANY**

**APRIL 30, 1983**

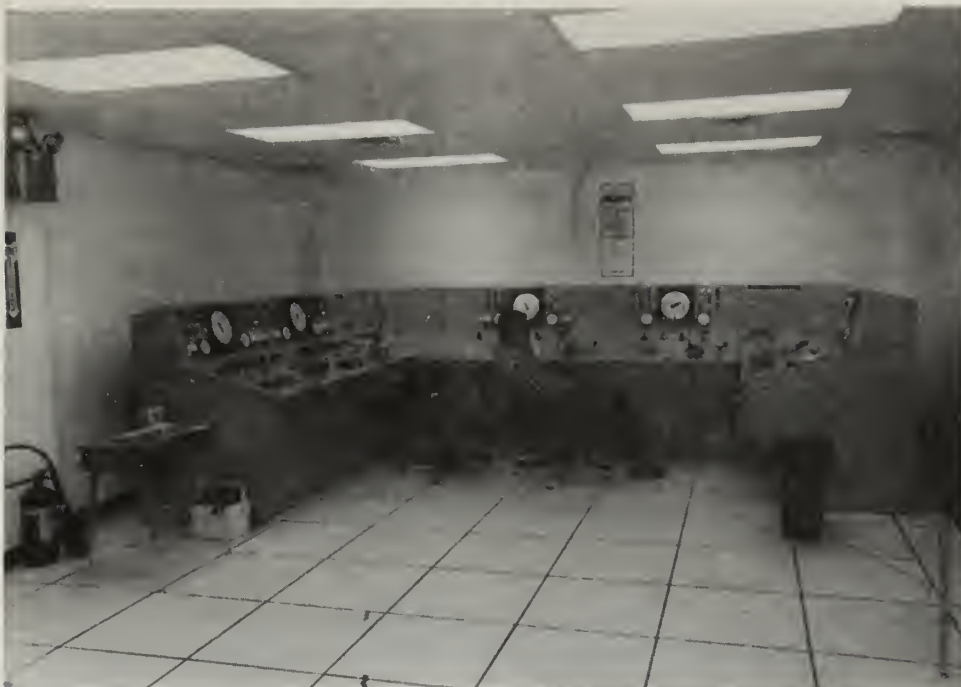
**Figure 4-21**

Control Panel for all Hoists Located in the Temporary Control Room Attached to the Service Shaft Headframe.

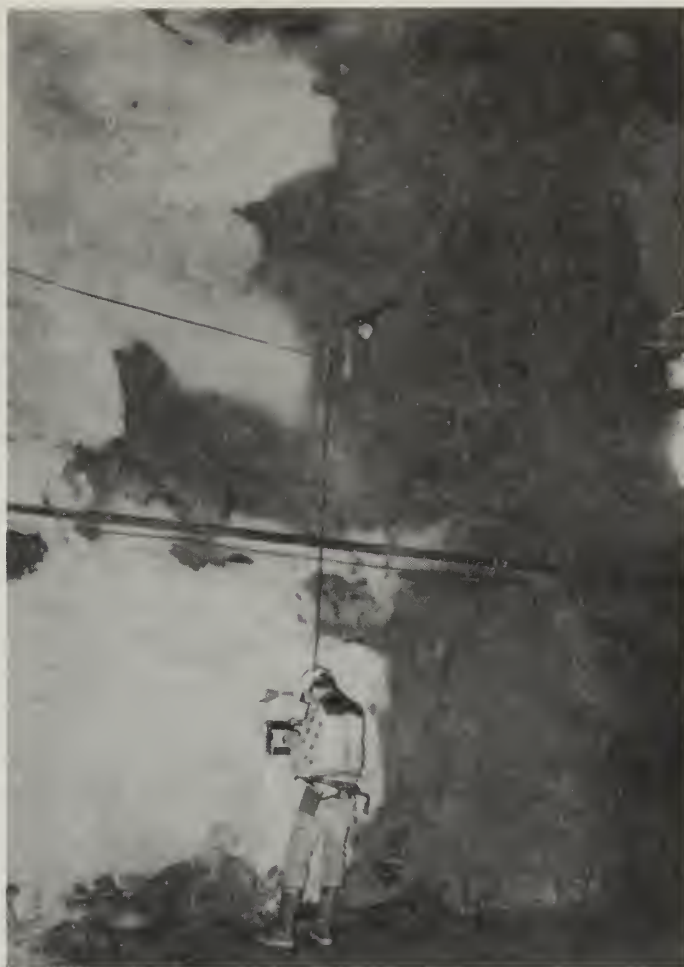
**Figure 4-27**

Installing Gas Monitoring System  
Upper Void Level

As noted in the 1980 report, the shafts were classified as gassy by MSHA on January 2, 1980. The ventilation system has been designed to comply with gassy mine regulations and conditions. Gas monitoring is discussed in Section 7.7.4. See Figure 4-27 for installation of the Gas Monitoring System.

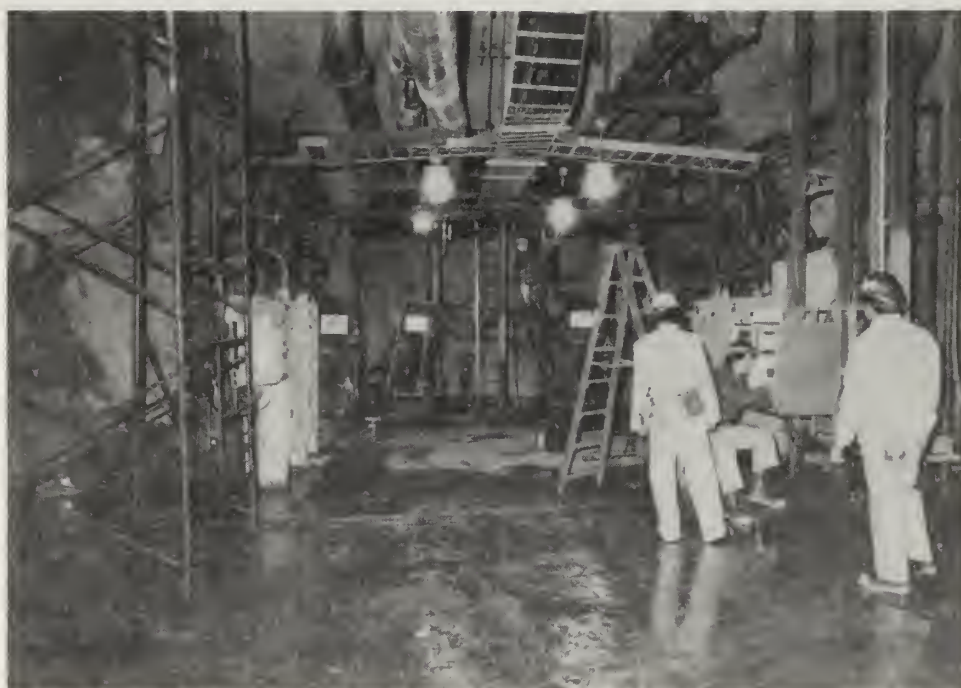
**Figure 4-28**

Pump Station - Upper Void Level
